Technical Service Bulletin

67006, Life Preserver, Hammerhead, Black, CSF

ISSUE DATE:	June 06, 2014	TSB NUMBER	TSB-14-004
--------------------	---------------	-------------------	------------

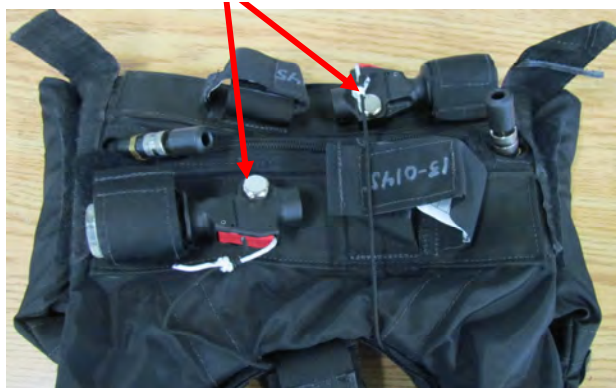
Figure 1: Life preserver Hammerhead unfold, Neck area

This Technical Service Bulletin recommends that Hammerhead Life Preservers within the above listed serial numbers be inspected for potential pressure loss at the inflators during inflation. The cause of CO₂ escaping at the inflator during inflation has been identified to be cross threading and/or an improperly torqued hex cap nut.

Pressure loss during inflation can result in an underinflated or partially inflated life jacket, regardless if it is automatically or manually fired.

Tulmar recommends performing life jacket inspections with specific attention on the inflator hex cap nut as presented in this TSB.

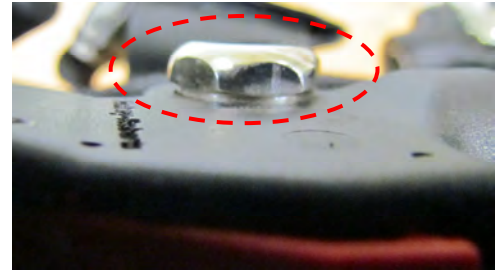
Figure 4: Hex cap nut properly threaded

- a. When the hex cap nut is properly installed, it will sit perpendicular to the inflator body (figure 4). Verify the torque applied on the hex cap nut is between 25 and 30 in.lbs using the torque wrench. Record the jacket serial number and the action taken in a log book. Once both inflators have been verified, proceed to step 11.

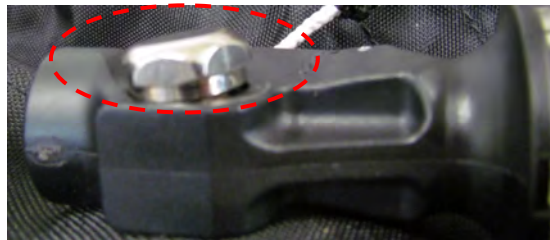
Figure 5: Cross threaded hex cap nut

- b. When a hex cap nut is cross threaded, it will appear angled to the inflator body as can be seen in figure 5

5. Unscrew the hex cap nut using the ratchet and remove the inflator from the bladder inflation valve.

6. Visually inspect the threads of the brass bladder valve to ensure they are not damaged. To confirm the integrity of the threads on the valve, screw on a **NEW** hex cap nut, by hand, without the inflator.

- a. If the threads on the valve are undamaged, the cap nut will easily engage on the valve and will thread/unthread completely, easily and freely. Proceed to step 7 to 11.
- b. If it is difficult to screw on the hex cap nut completely and freely by hand, the valve threads are damaged and the entire bladder must be replaced with new one. Proceed to step 12 to 15.

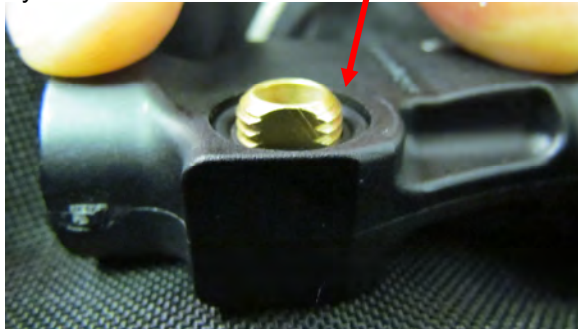
Figure 9: Inflator properly seated on valve stem

7. Ensure the two valve o-ring seals are present on the inflator. Re-install the inflator ensuring fabric is not caught between the inflator body and the bottom of the inflation valve. Refer to figure 6 for proper alignment of the cover, figure 7 show a cover improperly aligned on the valve. When the cover is properly positioned, 3 full threads will be visible protruding from the inflator body (*See figures 8*). Compare to figure 9 which present the result when fabric get caught between the valve and the inflator.

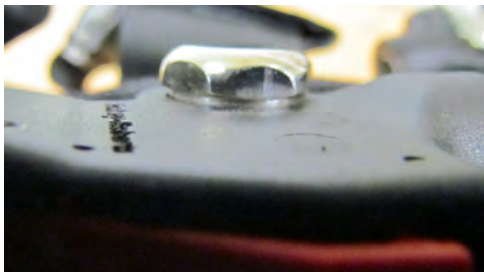
Figure 10: Hex cap nut properly threaded

8. Screw on the new hex cap nut and thread it by hand making sure it is properly engaged on the valve. Verify the cap is not cross-threaded (figures 10 and 11).

9. Torque the hex cap nut to 25-30in.lbs.
10. Once both inflators have been completed, record the jacket serial number and the action taken in a log book.
11. Inspect, rearm and repack the life preserver according to the user's manual.
12. In the event a valve thread is damaged, the entire bladder will need to be replaced. Carefully remove the bladder from the jacket. The bladder must be kept for further inspection by Tulmar.
13. Insert a new bladder into the jacket. Refer to Tulmar Work Instruction 0015 for proper bladder installation.
14. Record the jacket serial number and the action taken in a log book
15. Inspect, rearm and repack as required the life preserver according to the user's manual.
