Technical Service Bulletin

Hammerhead Life Preserver

ISSUE DATE:	June 04, 2019	TSB NUMBER	TSB-19-003
--------------------	---------------	-------------------	------------

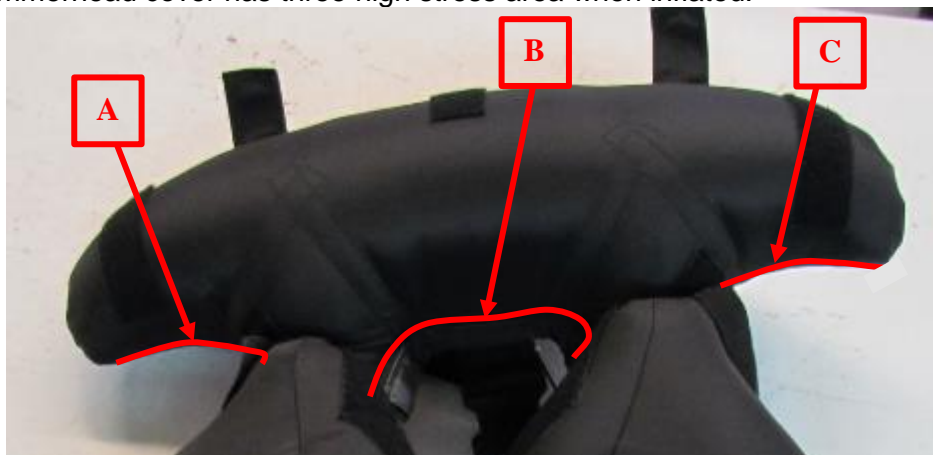
Figure 1 Three High Stress Area

If there is a broken thread in any of these areas, the cover may rupture during manual or automatic inflation. Should this occur, the jacket will lose its buoyancy because the chest lobes won't open. The user's head may be pushed forward when the bladder erupted from the cover. In certain cases, the bladder could rupture which would cause the total loss of buoyancy and produce a loud noise very close to the user's head.

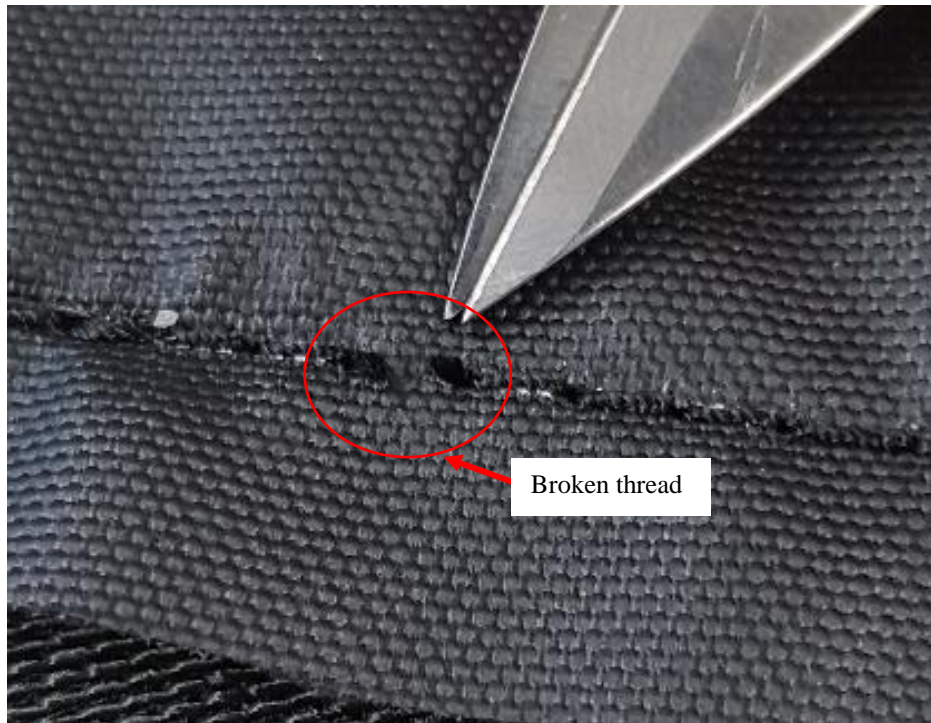
Figure 5 Broken thread

5. Use a flashlight to inspect the stitching on each side of the seams and look for any gaps in the stitching. A broken thread will look like the figure below.

6. If a broken thread is found or suspected, please contact Tulmar for an RMA number to return the life preserver to Tulmar for repair.
7. If no broken threads are found, the life preserver can be reassembled, rearmed, repacked and stored following the service manual. Record the life preserver serial number and the action taken in the maintenance record.
