Technical Service Bulletin

SINGLE PERSON LIFE RAFT, Inspection limit on floor patches.

ISSUE DATE:	September 26, 2014	TSB NUMBER	TSB-14-007
--------------------	--------------------	-------------------	------------

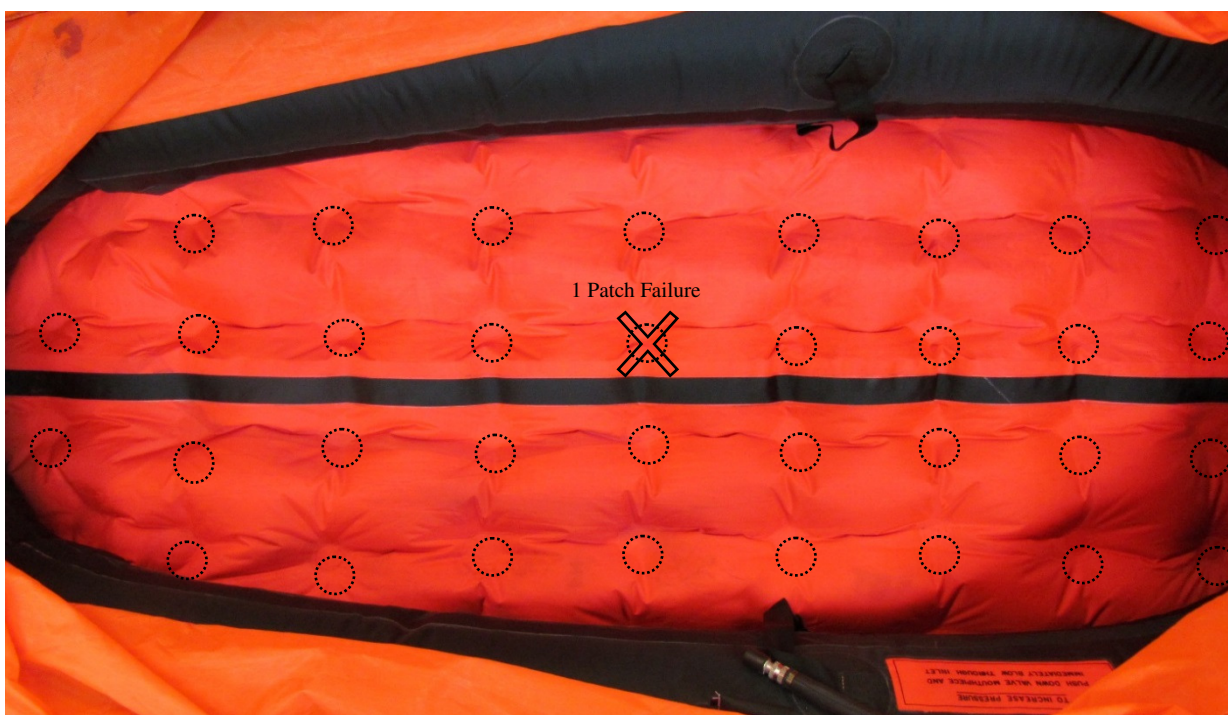
- Acceptance criteria 1 (Refer to figure 2)
One floor patch failure is acceptable anywhere on the floor

Figure 2: Acceptance criteria 1 – One floor patch failure

During periodic inspection, properly inspect the floor of the life raft and verify the integrity of all floor patches. There are 3 acceptance criteria on floor patch failure, any other conditions will fail the inspection and the raft must be removed from service and returned to an approved maintenance facility for floor repair.

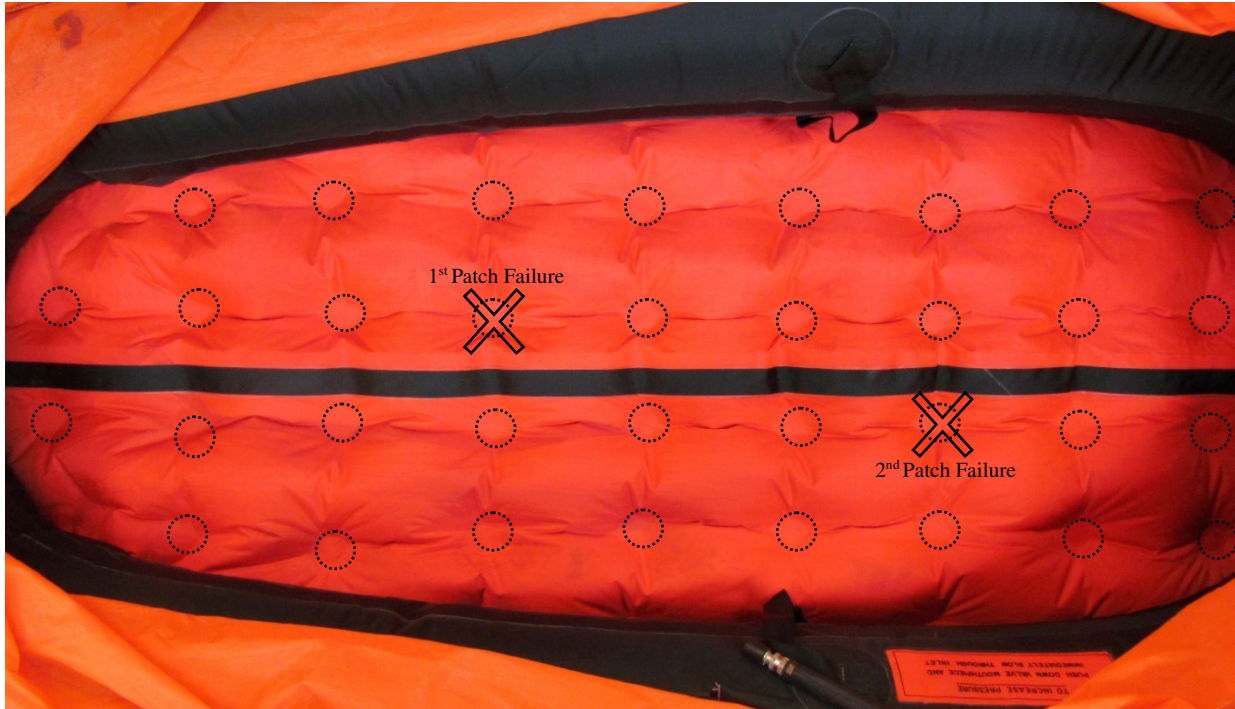
- Acceptance criteria 2 (Refer to figure 3)
Failure of two floor patches is acceptable with a minimum of 2 good patches in between.

Figure 3: Acceptance criteria 2 – 2 patch failures with 2 good patches in between.

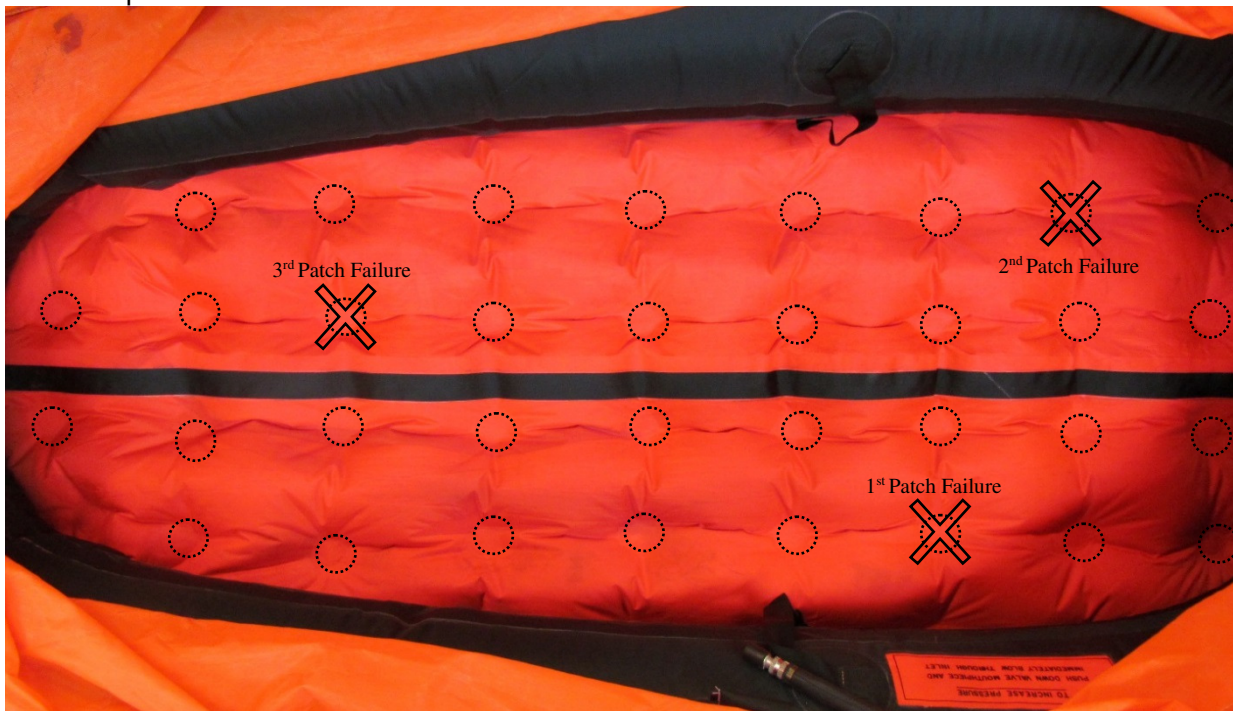
- Acceptance criteria 3 (Refer to figure 4)
A maximum of 3 failed floor patches is acceptable with a minimum of 2 good floor patches between each failure.

Figure 4: Acceptance criteria 3 – Maximum of 3 patch failures with 2 good patches in between each failure
