Technical Service Bulletin

6XL LIFE RAFT, Kinked hose and inflation system connections.

ISSUE DATE:	October 09, 2015	TSB NUMBER	TSB-15-001
--------------------	------------------	-------------------	------------

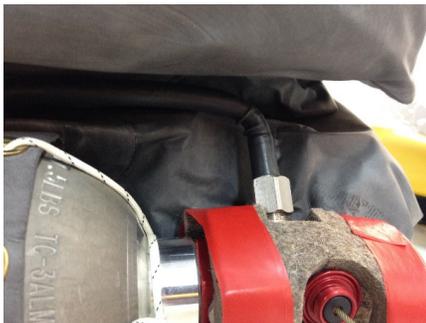
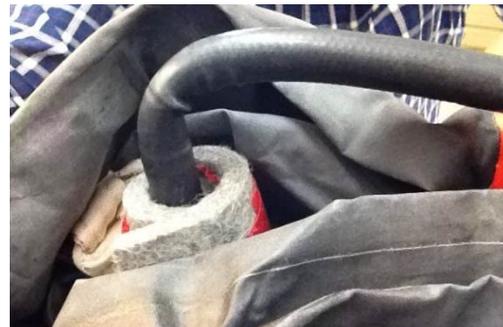
Under regular maintenance cycle of the 6 man life raft P/N 61003, it was found that the hose 3715-1 tends to kink next to the fittings when the raft is vacuum packed. Therefore, Tulmar recommends during regular service maintenance to inspect the hose and replace the hose if it's kinked. Refer to figures below for kinked hose. Tulmar is also recommending a torque value of 30ft-lbs on all connections of the inflation system in order to improve sealing.

Inflation performance is a major aspect for life saving device. Hose kink and CO2 leakage through a “loose nut” could have had a negative impact on raft inflation performance.

The hose has to be inspected and replace if it's kinked. During packing, extra attention must be taken when bending/placing the hose within the raft.

New revision of the Packing procedure specifies torque value of 30ft-lbs on all connections.
