## Technical Service Bulletin

67006, Life Preserver, Hammerhead, Black, CSF

<b>ISSUE DATE:</b>	June 12, 2014	<b>TSB NUMBER</b>	TSB-14-005
--------------------	---------------	-------------------	------------

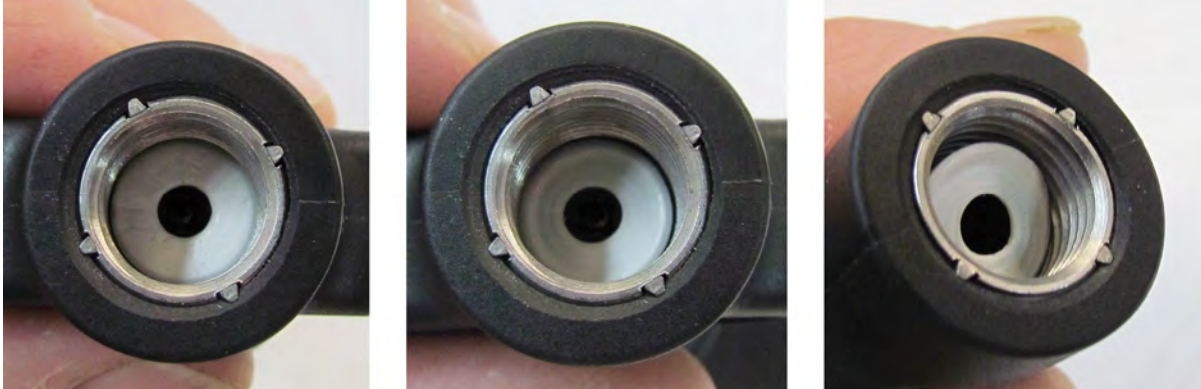
Hammerhead Life Preservers, p/n 67006, serial numbers 67006-13-001 to 67006-14-1083 were supplied with gaskets made of white, expanded PTFE material as shown in Figure 1. Repeated cylinder installations result in deformation of the gasket which may facilitate inadvertent gasket fall-outs.

**Figure 1, Inflator with white, expanded PTFE gasket**

When a gasket exhibits a tendency to fall out with little effort, it should be replaced.

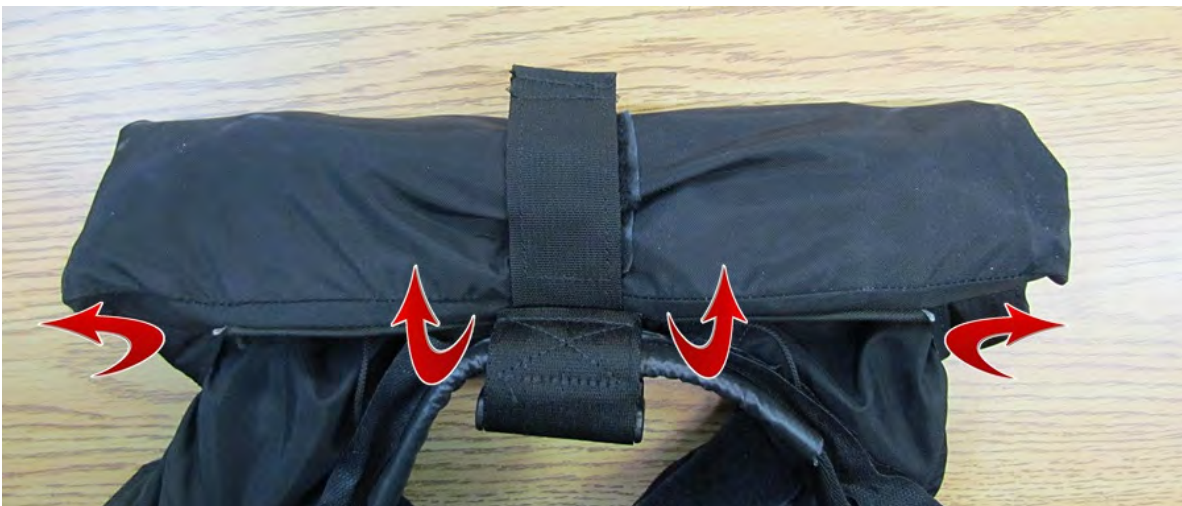
**Figure 2: Folded Head Lobe**

1. Lay the life preserver onto a flat, clean surface, chassis side (handles and pull cords) facing upwards.
2. Expose the inflation units by grasping the head lobe and separating the hook and loop fastening strips at the center and on each side to unfold.

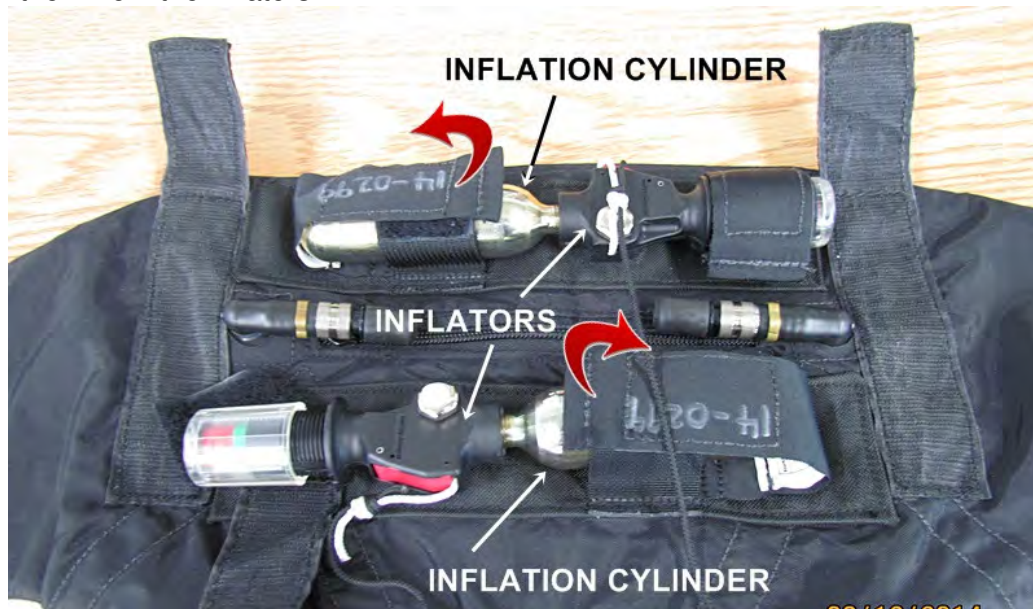
Figure 3, removing the inflation cylinders

3. Open the cylinder webbing loops. Grasp the CO<sub>2</sub> cylinders and turn counter-clockwise to unscrew them from the inflators.

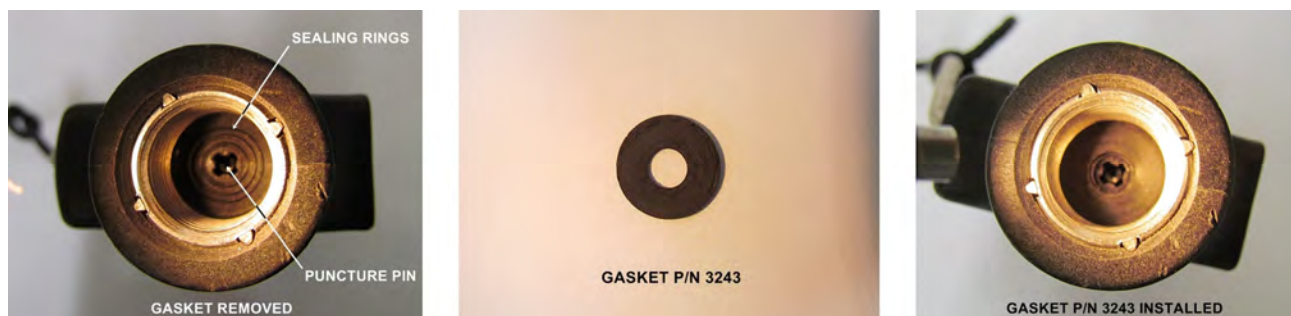
Figure 4, Installing the replacement gasket

4. Remove the white cylinder sealing gaskets from within the two inflators using a small tool.
5. One inflator at a time, insert replacement gaskets, Tulmar p/n 3243, ensuring the gaskets are well positioned at the bottom of the inflator cavities. Diligence will be required to ensure the edge of the gasket is well tucked into the lowest groove/thread.

NOTE: After the gasket is replaced, it will be more difficult to visually check if a gasket is in place. An aware and attentive user will realize something is wrong when installing the cylinder; when the gasket is properly installed, resistance is felt during the last quarter turn of the cylinder. When the gasket is misplaced, resistance can be felt for as much as the last 2 turns of the cylinder. When the gasket is missing, no resistance is felt at all as the cylinder bottoms out.
