Technical Service Bulletin

67006, Life Preserver, Hammerhead, Black, CSF

ISSUE DATE:	June 06, 2014	TSB NUMBER	TSB-14-004
--------------------	---------------	-------------------	------------

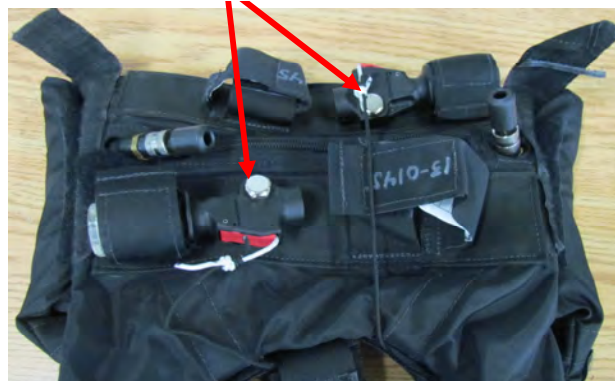
Figure 3: Unfold jacket head lobe

Inflator Hex Cap Nut

3. Open the cylinder webbing loops. Grasp the CO₂ cylinders and turn counter-clockwise to unscrew it from the inflator mechanisms. Ensure the cylinder gaskets are still present after having removed the cylinders.

4. For both inflators, visually inspect the position of the Hex Cap nut.
