Technical Service Bulletin

SINGLE PERSON LIFE RAFT, Inspection limit on floor patches.

ISSUE DATE:	September 26, 2014	TSB NUMBER	TSB-14-007
--------------------	--------------------	-------------------	------------

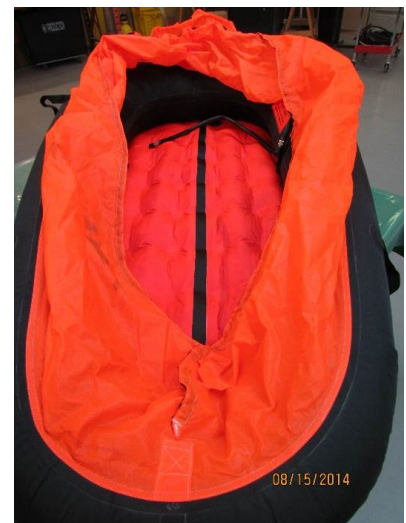
Figure 1: Single Person life raft

Floor patch failures can occur but they are not essential to the functionality of the raft. However, patch failure will affect the shape and the total volume of the floor.

If the inspection limits on floor patches are not respected, the change in floor volume and shape increase the stress on the remaining dimple patches. This increases hoop stress is trying to tear the floor patch apart in peel. In the case of too many failed patches with a floor inflated at 1 psi, the remaining floor patches might fail one after the other because of the hoop stress increase.

In order to maintain the overall performance of the single person life raft, a limit is now set on floor patch failure. The floor inspection is now defined by the three acceptance criteria presented below. For any conditions other than these three scenarios, the raft must be removed from service and returned to an approved maintenance facility for repair.
